SITE PHOTOGRAPHS

Bioengineering works

Sundali nala

after 6 months of construction

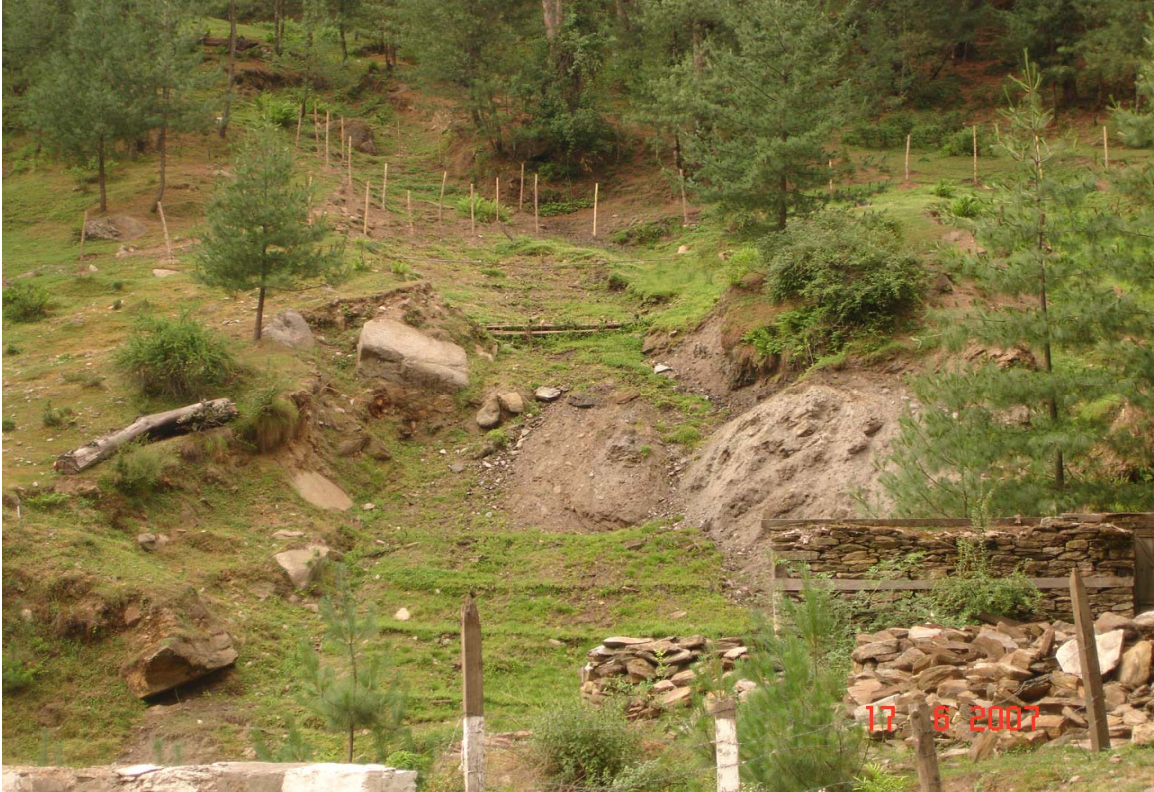
Plate No. 1: Close view of the Sundali nala gully and performance of the plant growth after 6 months of bioengineering construction

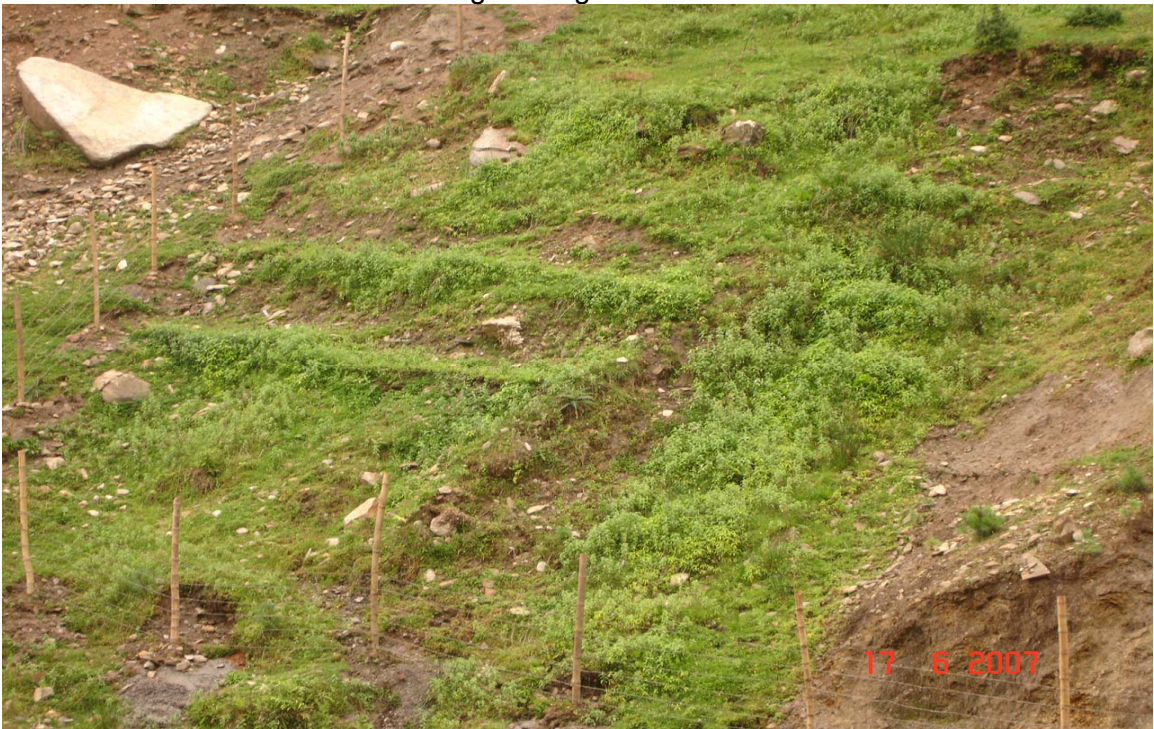
Plate No. 2: Close view of the brush layering technique behind the barbed fence in Sundali nala gully and performance of the growth after 6 months of bioengineering construction.

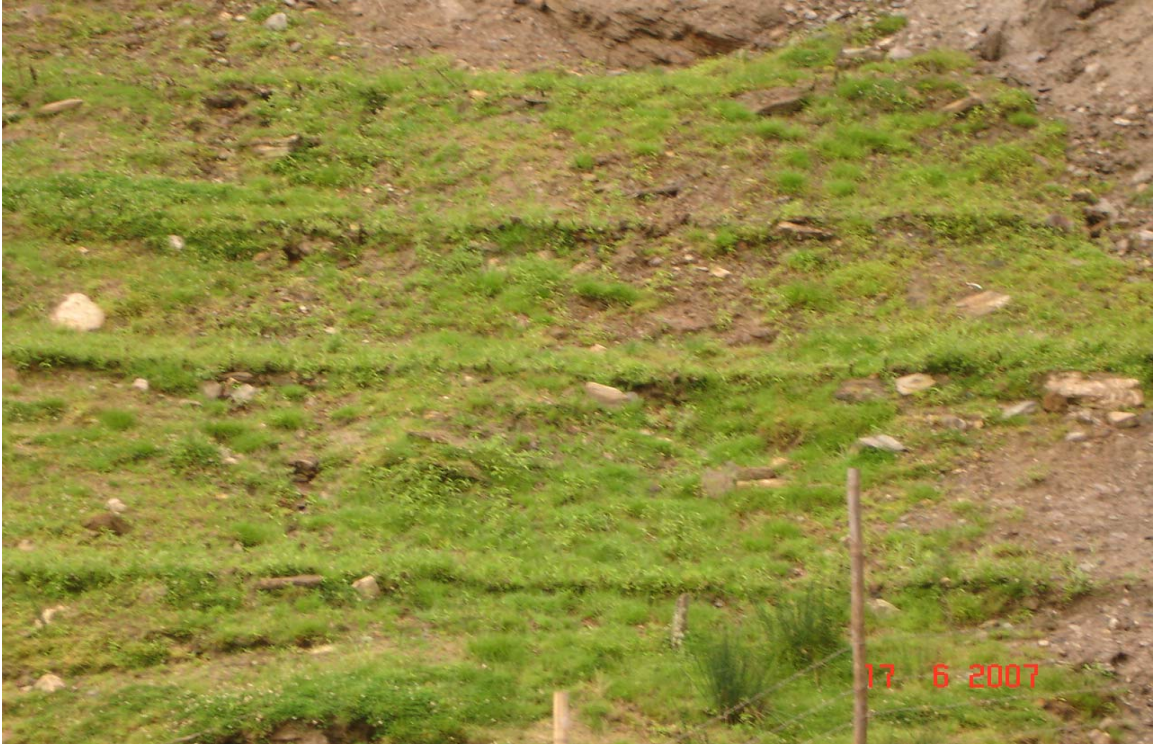
Plate No. 3: Several rows of brushlayering works in Sundali nala gully and performance of the growth after 6 months of construction.

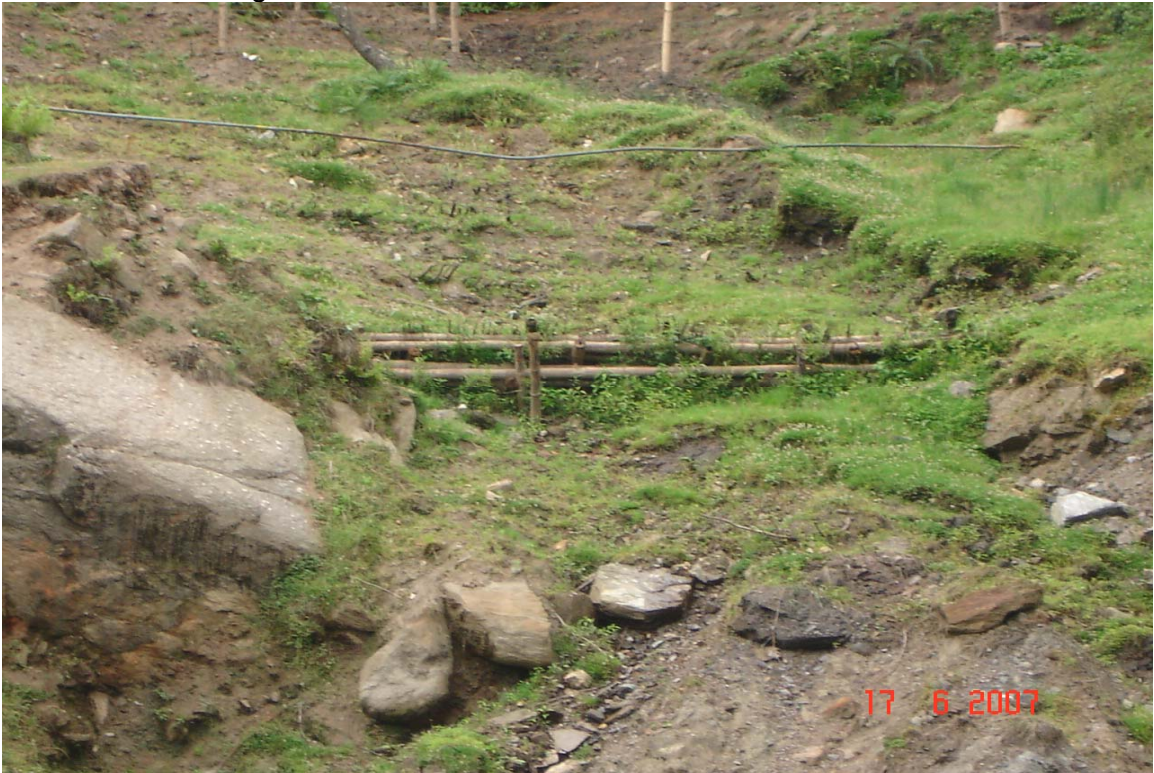
Plate No. 4: View of the upper part of Sundali nala gully showing bamboo cribwall construction after 6 months of construction.

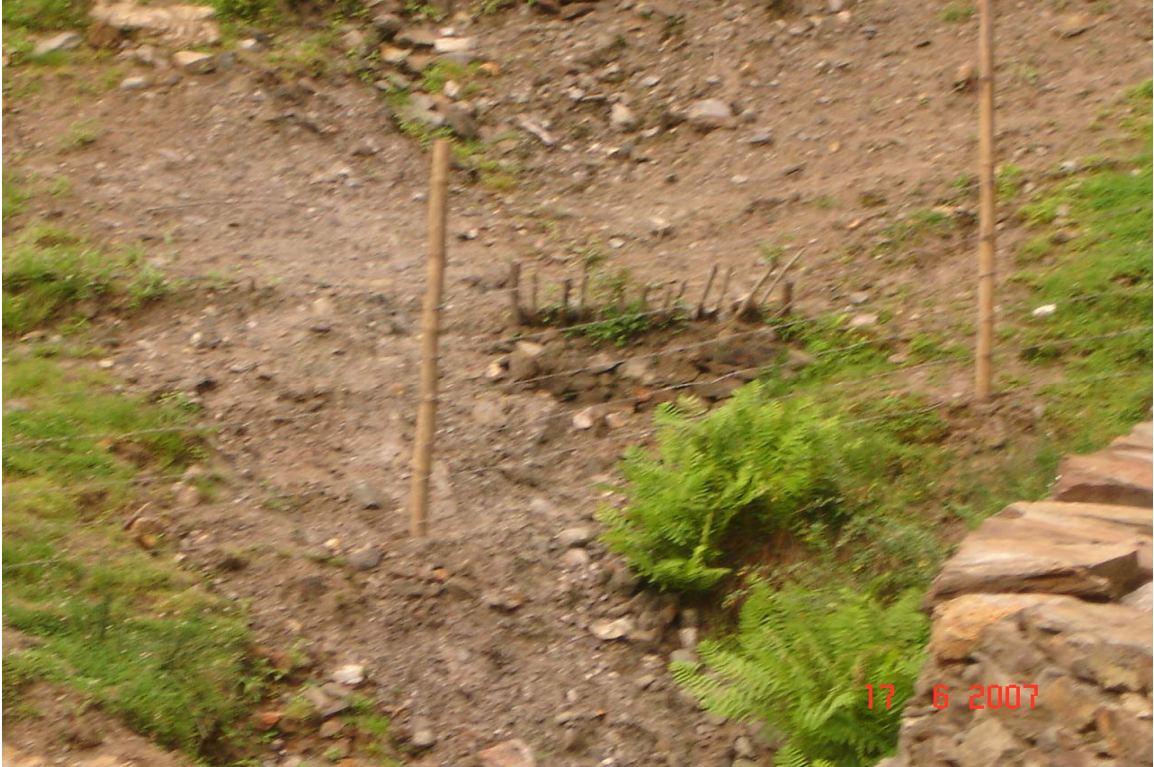
Plate No. 5: Vegetated palisade construction in the Sundali nala and performance of the growth after 6 months.

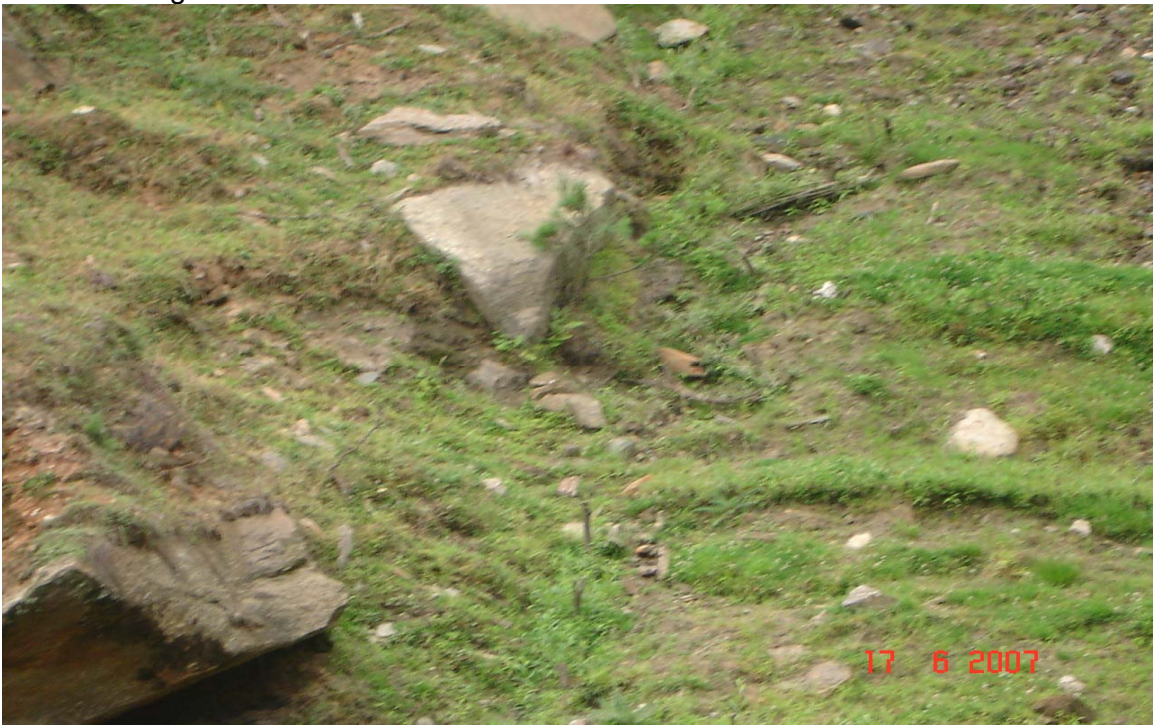
Plate No. 6: Live fascine construction in Sundali nala gully and performance of the growth after 6 months.
